## HLH ROTOR BLADE MANUFACTURING TECHNOLOGY DEVELOPMENT REPORT

Boeing Vertol Company  
P. O. Box 16858  
Philadelphia, Penn. 19142

September 1977

Final Report

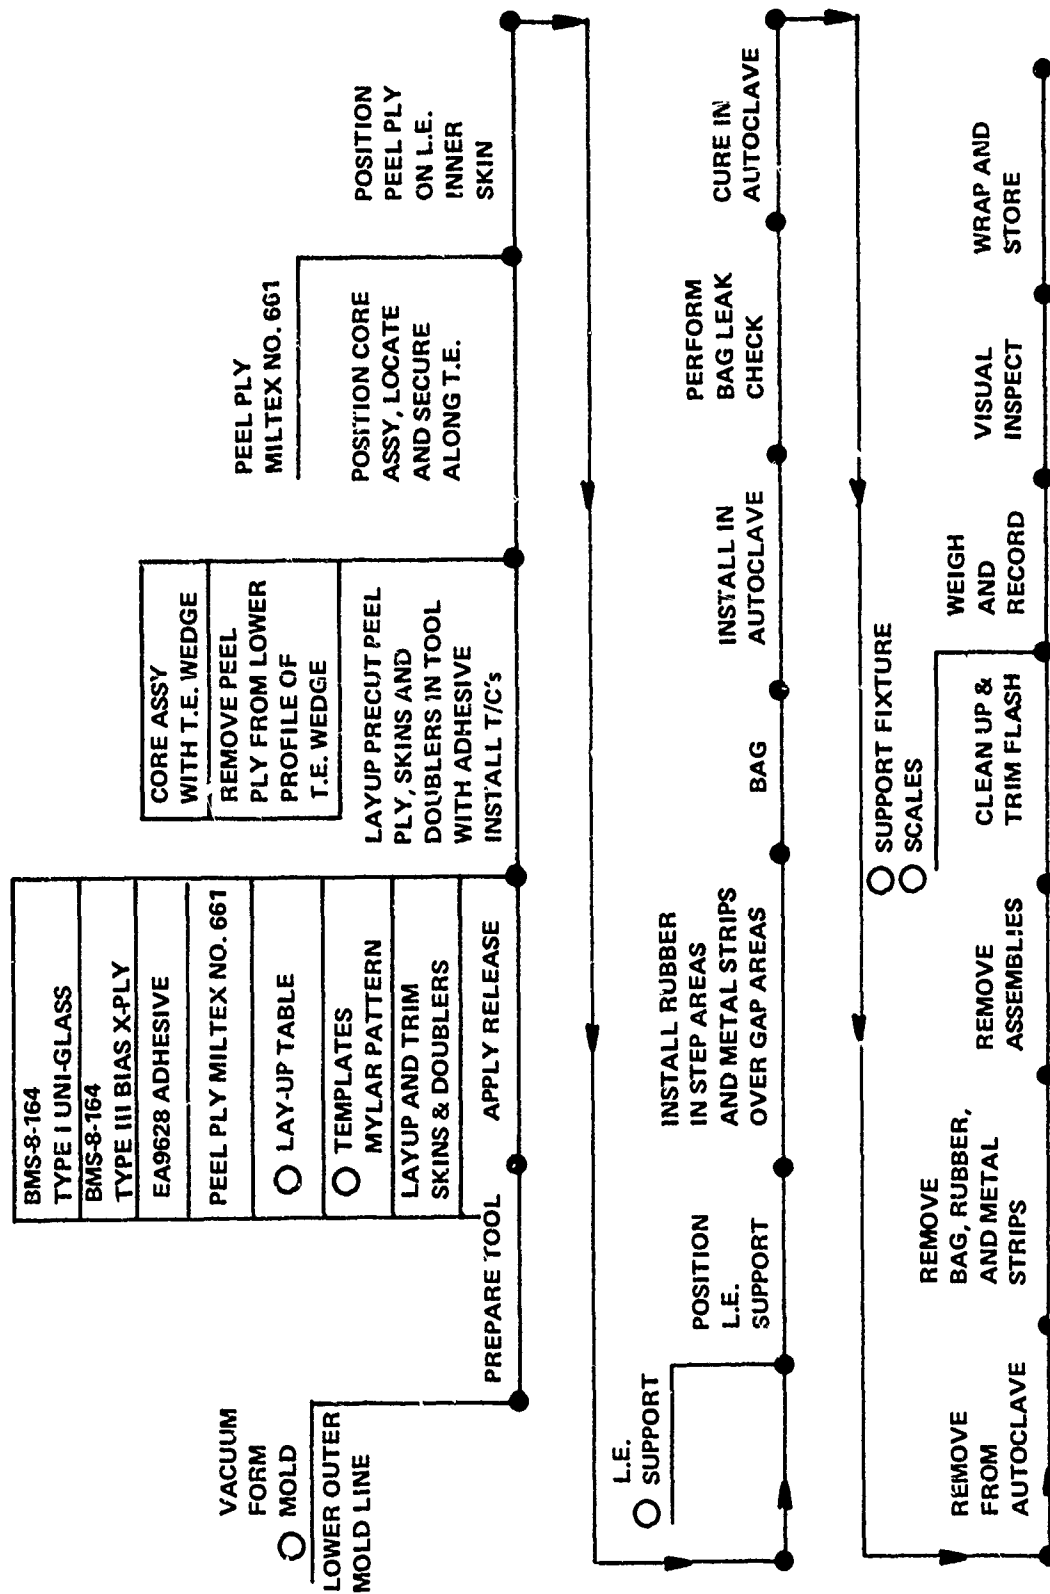
Figure 1. Typical Blade Operations Sequence "Daisy Chain" Chart

The committee consisted of key representatives from each functional department participating in the blade development program. Included were representatives from Project Engineering, Tool Design, Manufacturing Technology, Manufacturing Engineering, Quality Assurance, and Operations Management. Starting with the basic blade design concept, the committee analyzed each detail and component to identify tool requirements, processes to be utilized, and techniques required. In addition, potential problems or inherent risks were identified and analyzed. Primarily, the committee's action was achieved through the development of "daisy chain" charts of sequential operations for each part and component of the blade. A typical "daisy chain" chart is shown in Figure 1.

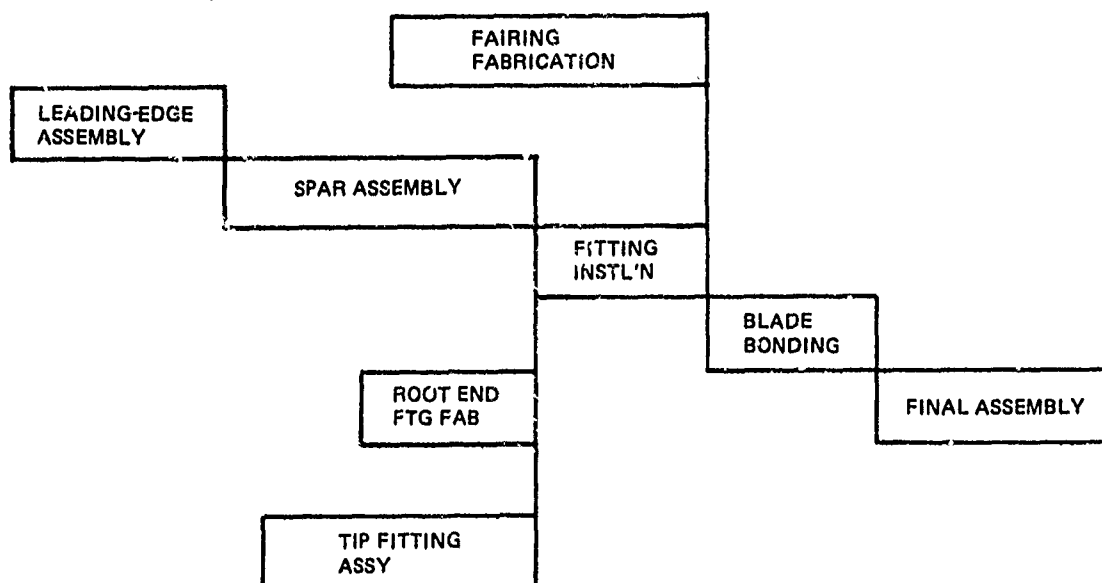
Figure 2. HLH Blade Fabrication Flow Diagram

The charts within this section identify the fabrication sequence used for the HLH blades (ATC configuration). Each chart is structured to indicate flow of various subassemblies and assemblies into a final blade. The overall flow diagram is shown in Figure 2; Figures 3 through 11 depict operations performed for each task. The blocks in each flow chart have

been sized to be time sensitive from a flow time viewpoint; i.e., small blocks represent short operations, larger blocks - longer operations.

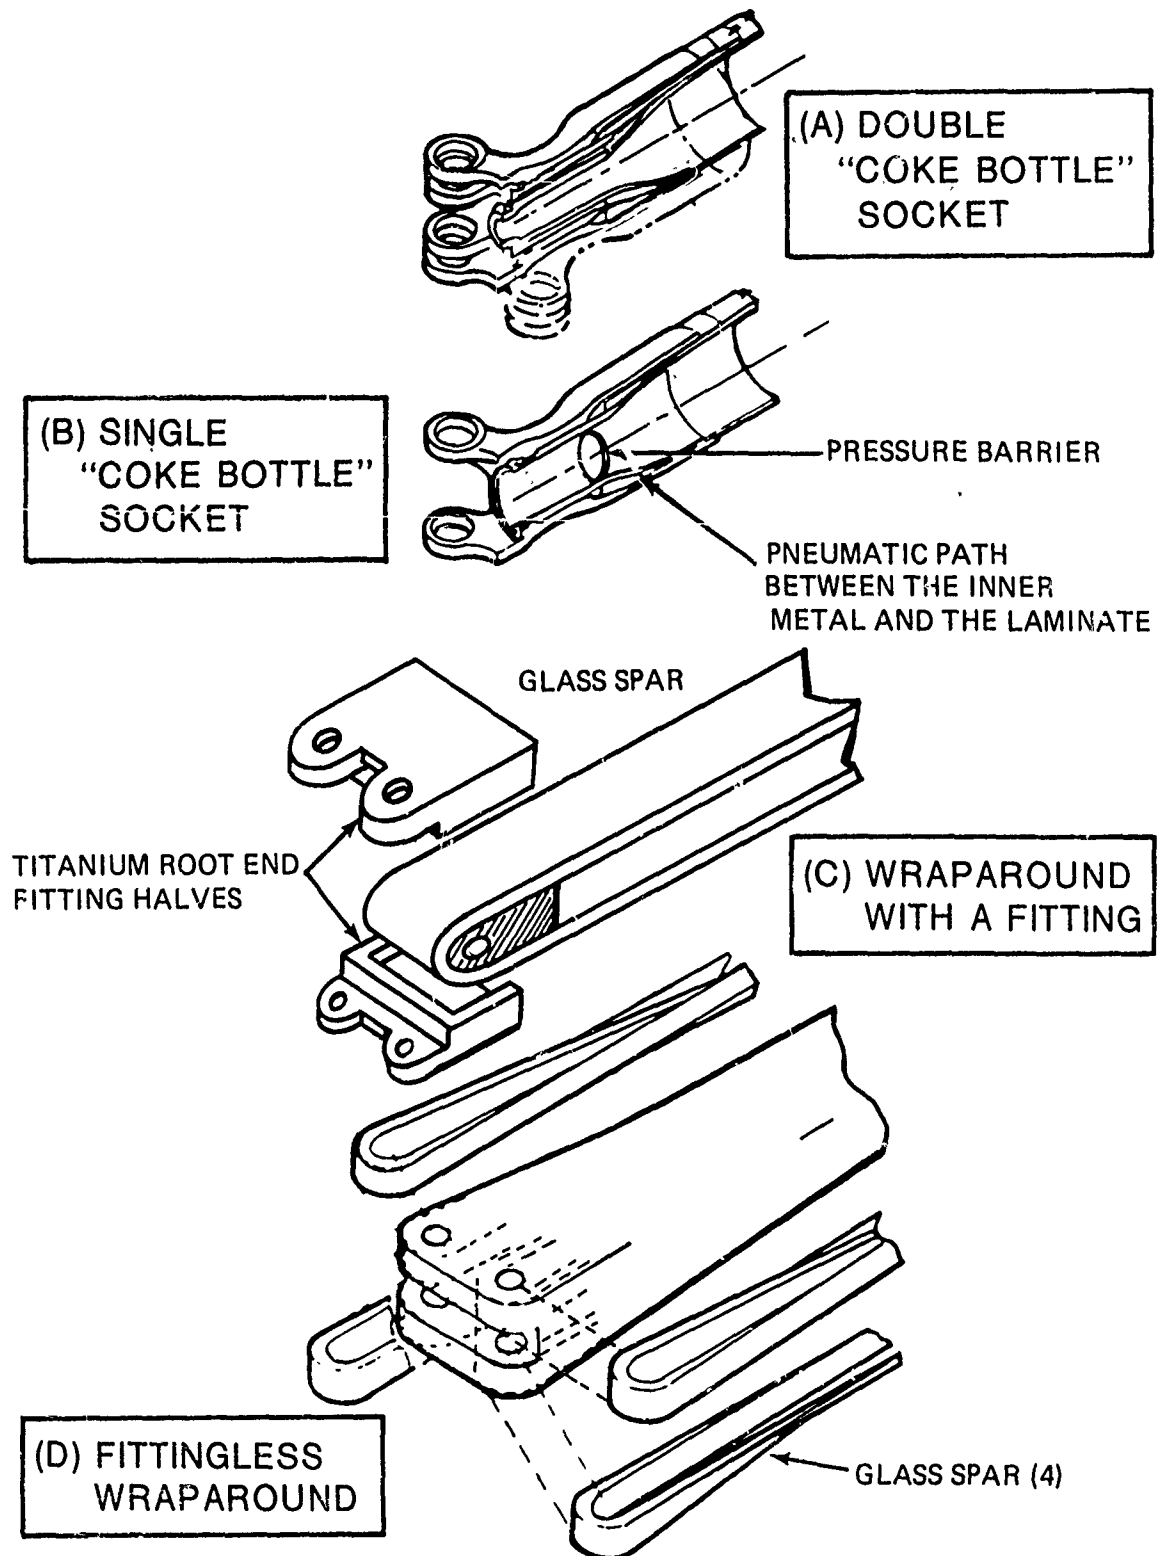
Figure 12. Root End Configurations Evaluated

1. Double Coke Bottle Fitting (Figure 12a)
2. Single Coke Bottle Fitting (Figure 12b)
3. 10-inch Wraparound (Figure 12c)
4. Fittingless Root End (Figure 12d)

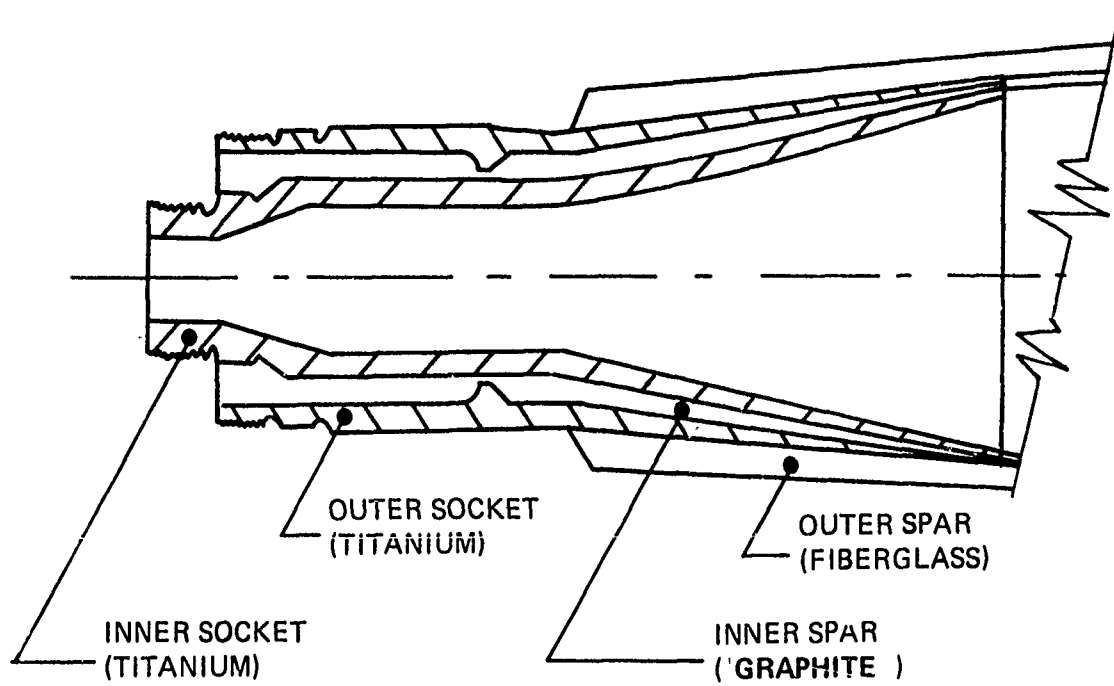
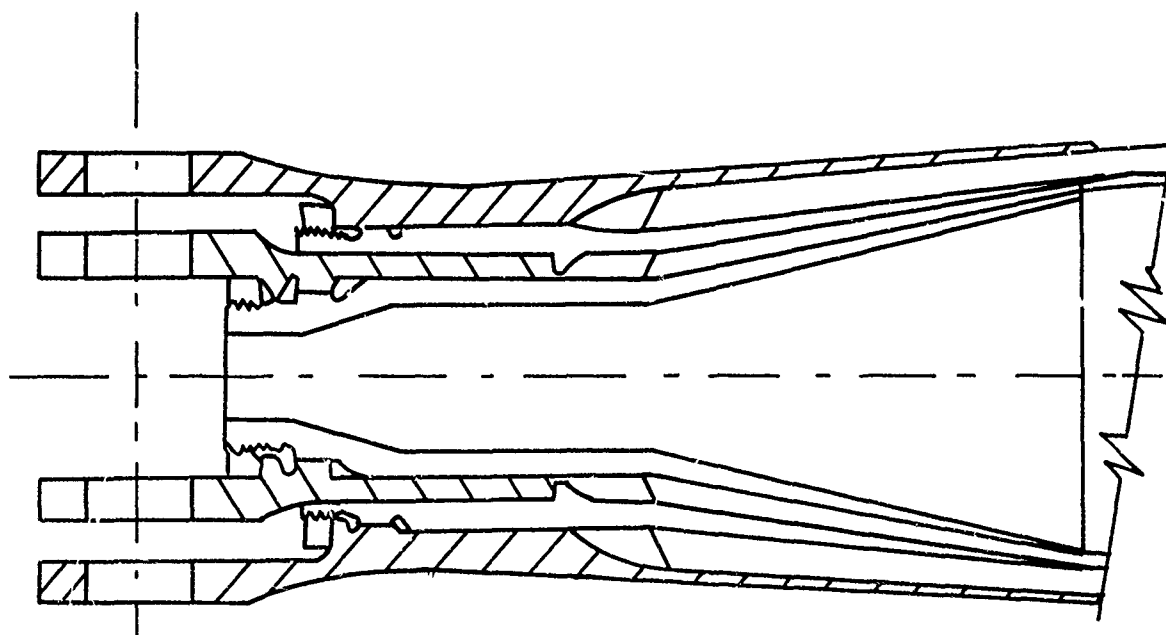
Figure 13. Double Coke Bottle Fitting

The Double Coke Bottle specimen (Figure 13) was layed-up on a bean bag and cured in a fiberglass tool in the autoclave. The bean bag was a contoured rubber bag made to the inner mold line (IML) of the spar minus a 30% bulk factor and filled with hollow aluminum balls. The bag was filled in a split mold to produce the contour, and then vacuum was

DOUBLE COKE BOTTLE CONCEPT (SHOWN AS CURED)

DOUBLE COKE BOTTLE FITTING (ASSEMBLED WITH OUTER SOCKETS)

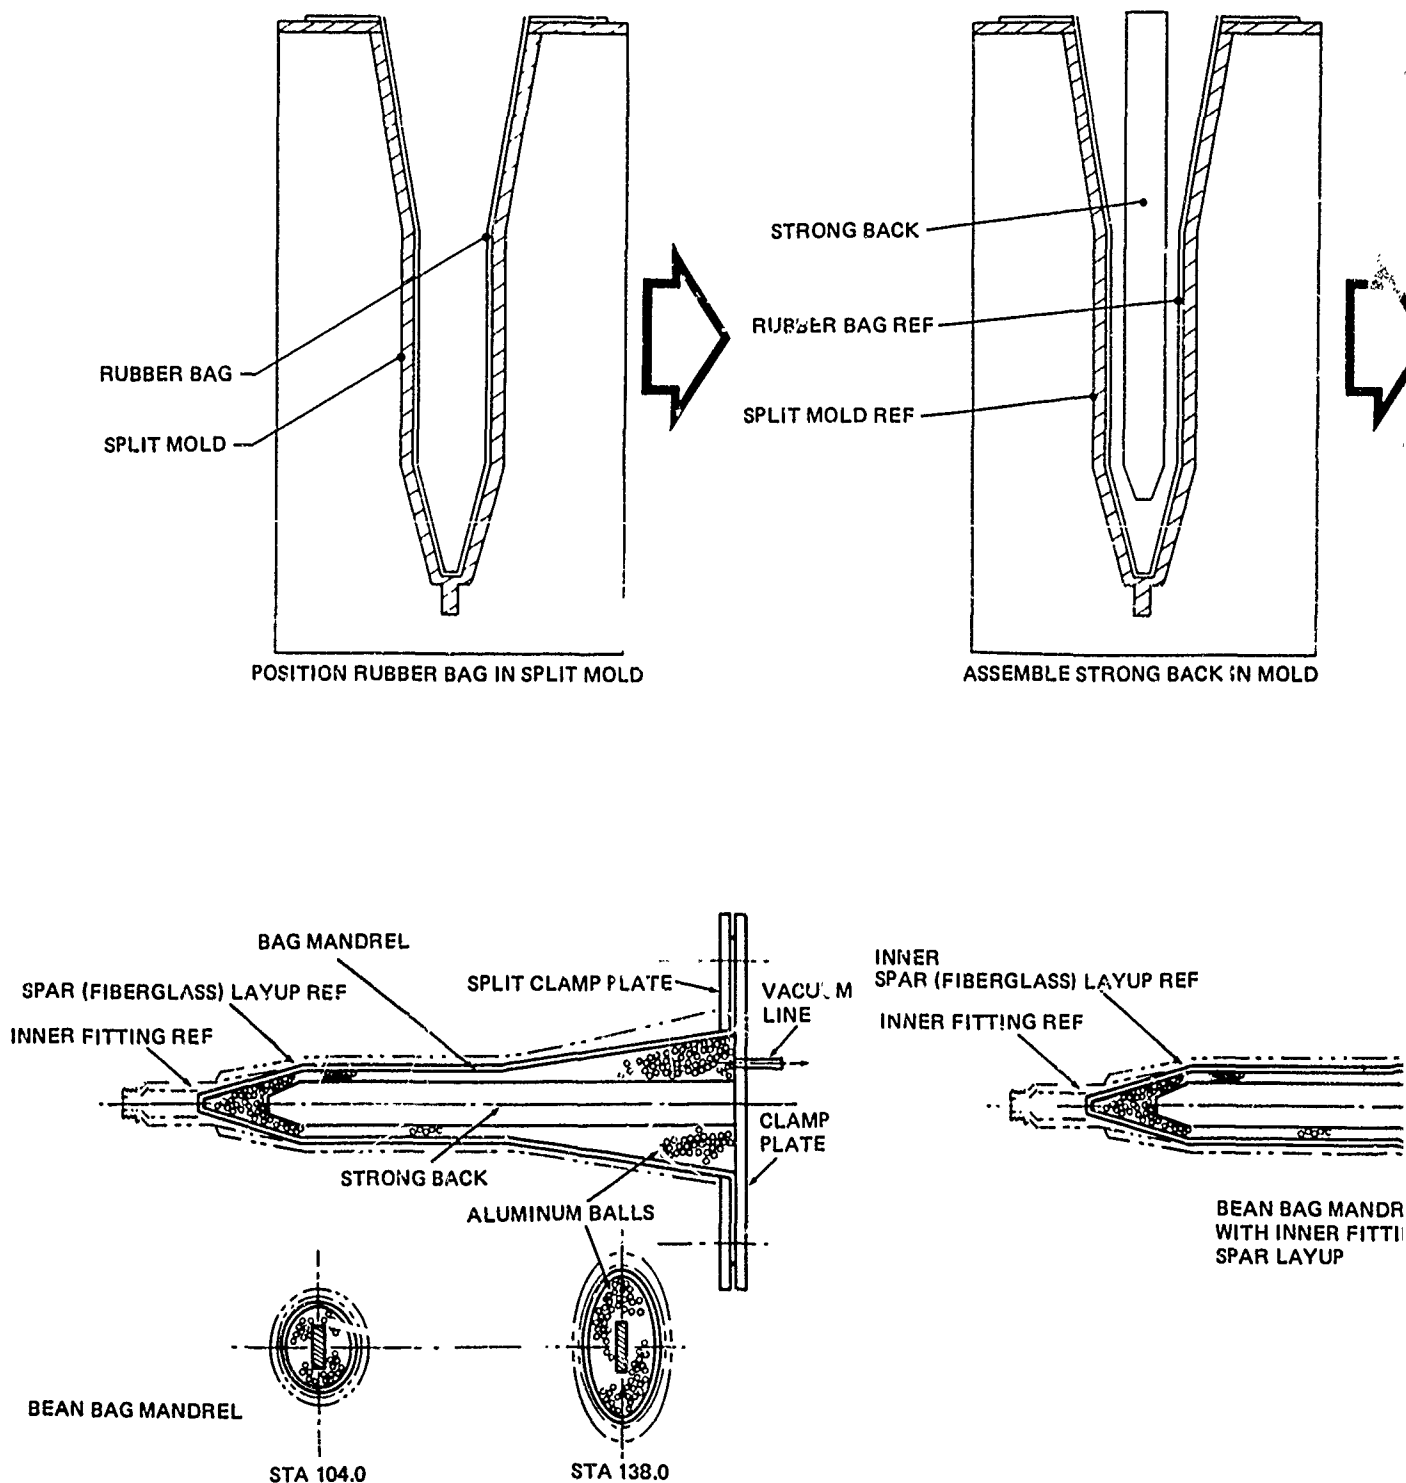
Figure 14. Fabrication and Buildup of Internal Bean Bag Mandrel

pulled to produce a solid mandrel suitable for laying up the fiberglass details. Figure 14 illustrates buildup of the bean bag mandrel. Vacuum on the bag must be maintained during the full lay-up period and until the specimen is placed in the curing tool.

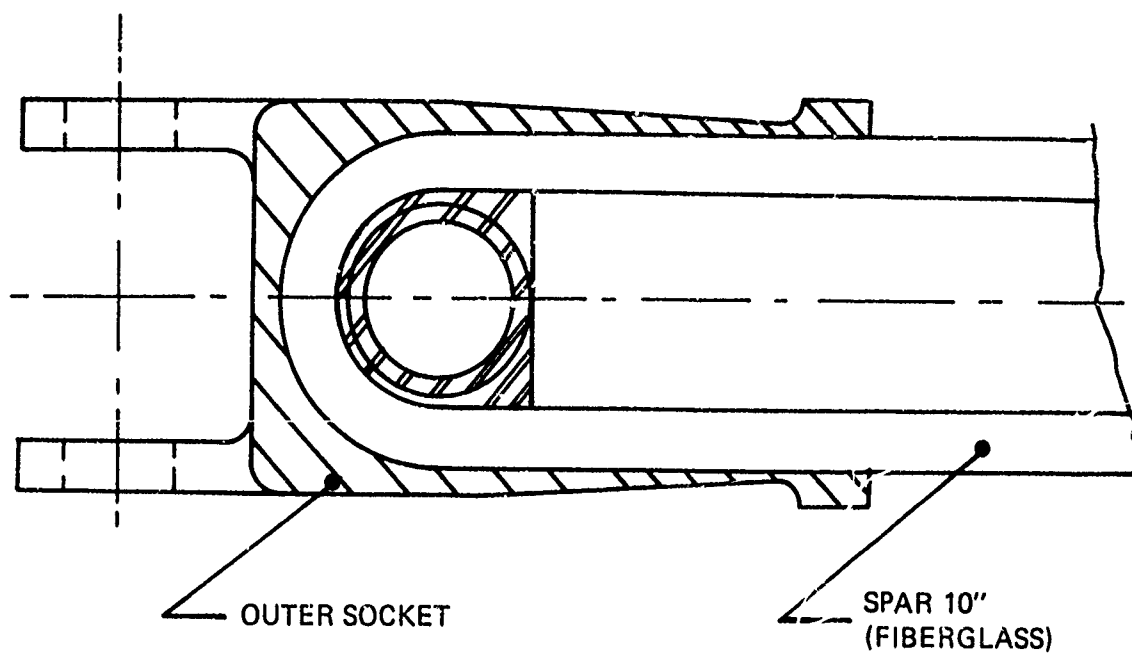
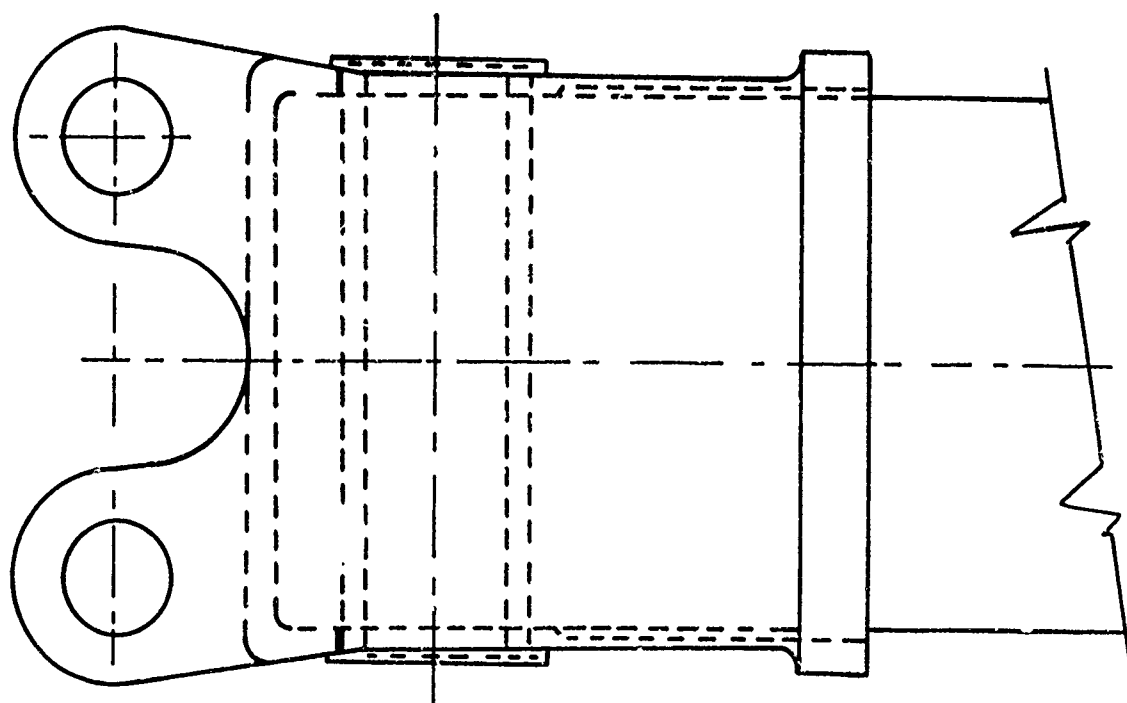
Figure 15. Ten-Inch Wraparound Fitting

Another concept for a root end using steel tools and the platen press was evaluated. This concept was known as the "Ten-Inch Wraparound Fitting". The tooling effort on this concept (Figure 15) was limited to designing and fabricating a tool that would prove the feasibility of lay-up, compacting and curing of 10-inch wide by 1-inch thick Uni-Fiberglass material around a 2.5-inch radius.

10" WRAP-AROUND CONCEPT

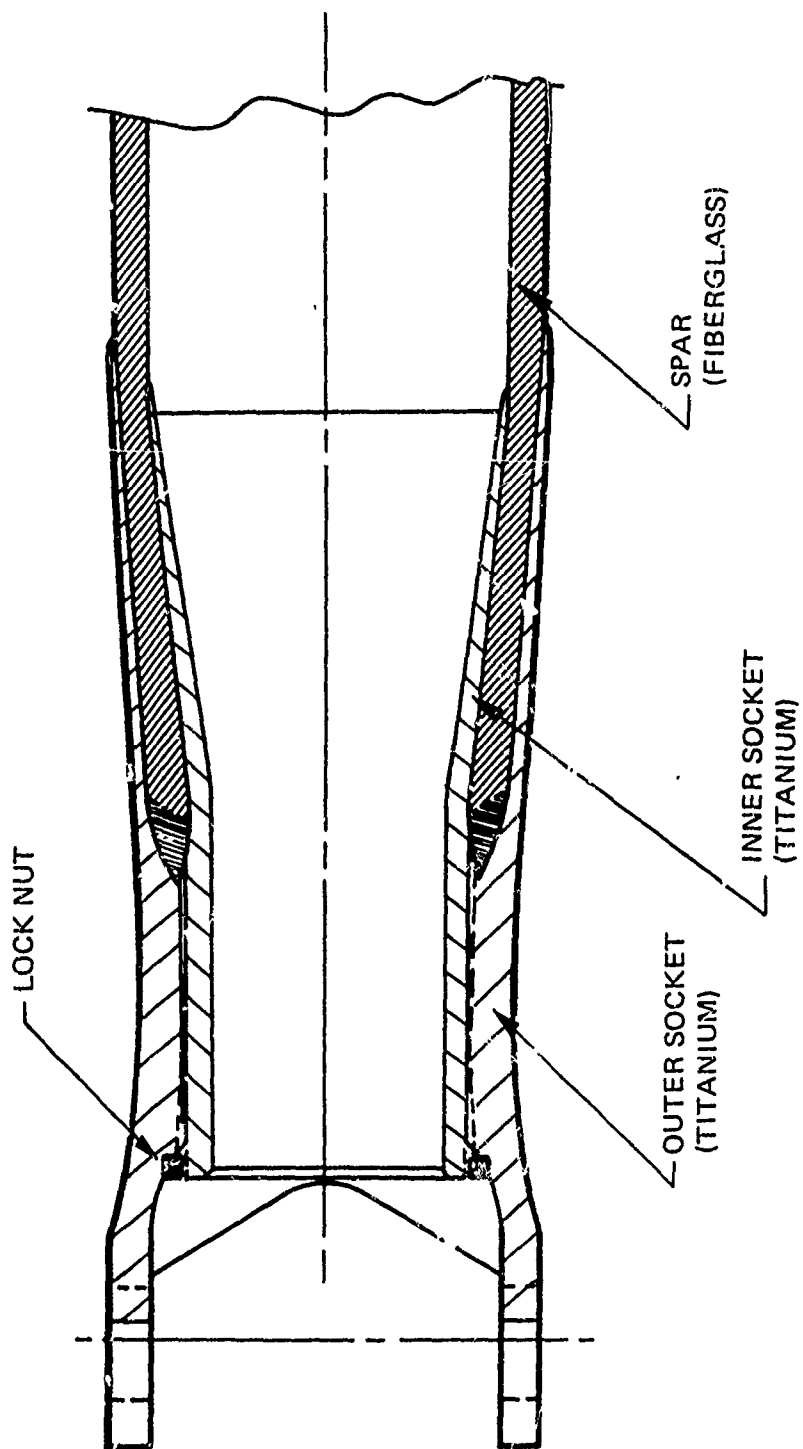
Figure 16. Single Coke Bottle Fitting

SINGLE COKE BOTTLE FITTING (ASSEMBLED WITH OUTER SOCKET)

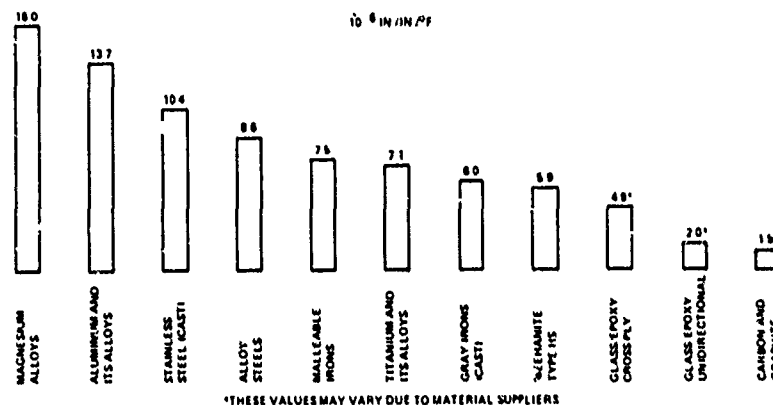
Figure 17. Coefficient of Thermal Expansion Comparisons

Using data for the previous root ends that were produced (Figure 17), the decision was made to produce an integrally heated steel tool to the new engineering design capable of making the test piece and, upon completion, being adapted to a full length tool. It was at this stage of the program that the fittingless root end configuration (Figure 18) was designed. The part was cured, and the design proved successful; Engineering, however, re-evaluated the design and minor changes were made that eliminated some detail parts resulting in changes to the outer mold line. The fittingless root end, or "wraparound" root end concept, with integrally heated steel tools was selected in the first quarter of 1972 for full-scale blade tool fabrication.

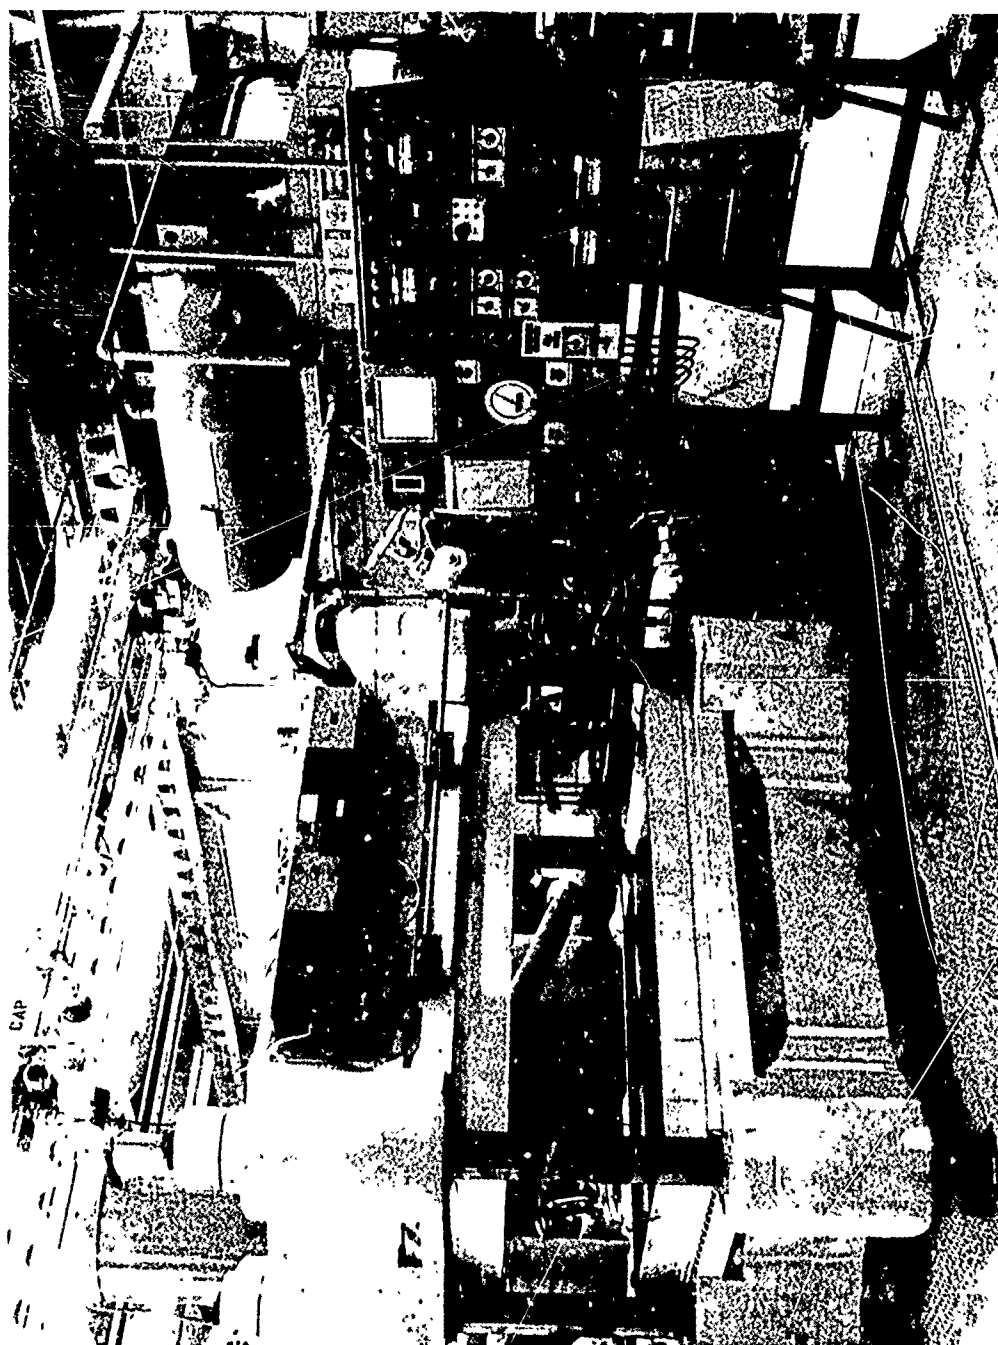
Figure 19. Platen Press

not require disassembly for loading or unloading of the parts, there is always a high risk of part contamination which could cause bond voids. A good example for use of oil heat is the platen press (Figure 19); the oil is circulated through a closed loop within the platens and through flex lines (which are never disassembled) to and from the heater and pump. The tools (normally less than 6 ft long with essentially constant sections) are placed in the press, and heat is applied to the tool from both top and bottom. The platen press concept was considered for the HLH blade fixtures; however, the large overall size and weight of these rendered mechanization of this concept impractical. It should be noted that, for platen press tools to be most efficient, full contact should be made with the platens to conduct heat into the tool, thereby eliminating any coring or ribs that result in a much heavier tool. It should also be noted that zone control (higher or lower heat in specific areas of the tool) in the platen press requires special plumbing and incurs additional costs. The HLH blade spar changes shape from a 9-in. by 12-in. section (approx) with a 0.5-in. wall thickness at the root end (Station 66) to a 3-in. by 16-in. section (approx) with a 0.18-in. wall thickness at the tip end (Station 552). See Figure 20.

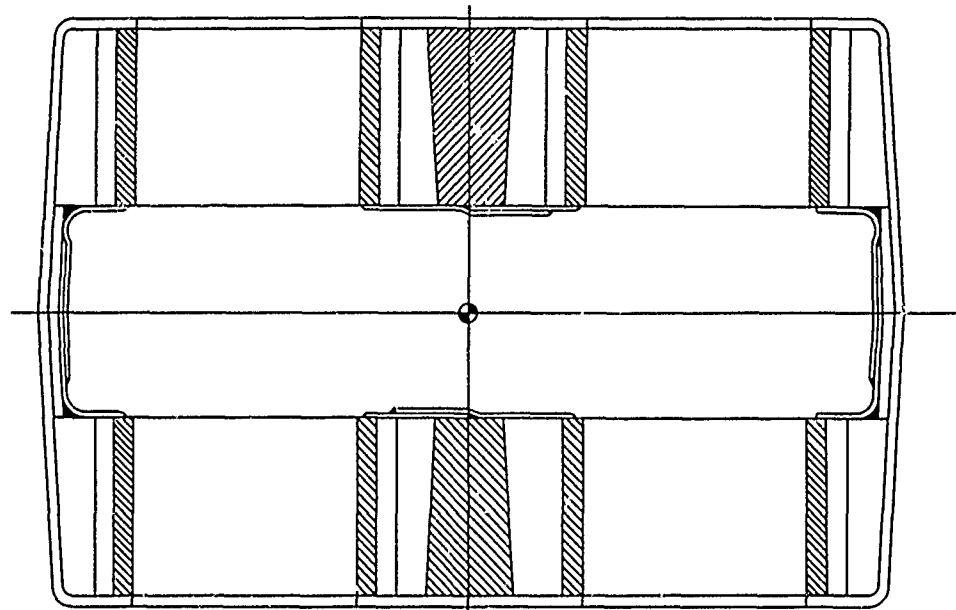
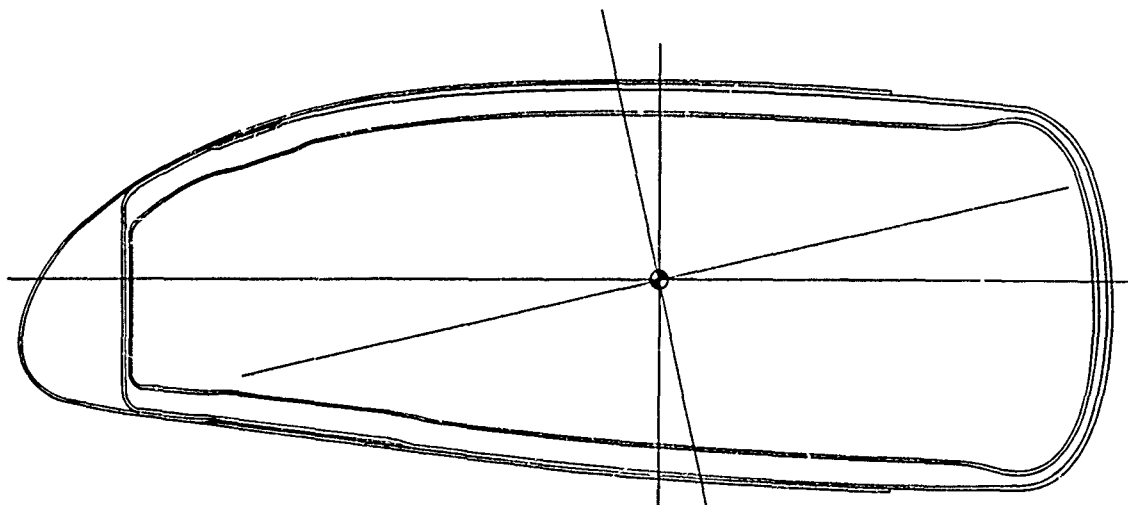
Figure 20. HLH Blade Spar Shape Transition

a. Root Shape.

b. Spar After Transition to 'D' Section

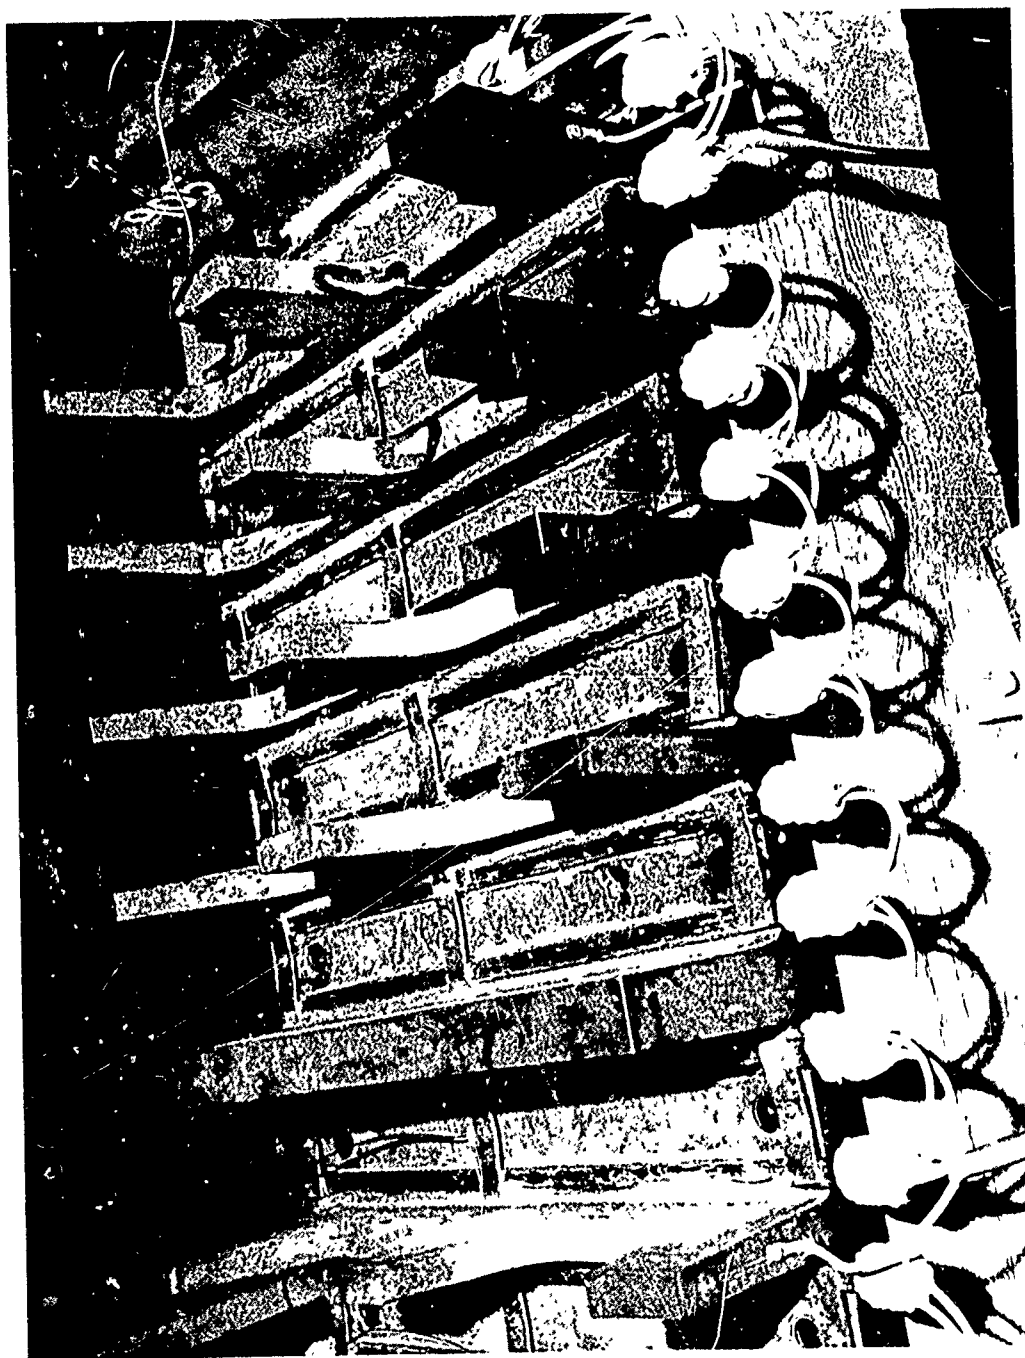
Figure 21. Strip Heater

Several types of electric heaters were investigated before selection of strip heaters for use in the major tools. The airfoil shapes and sections (tooling), required to withstand 80 to 100 psi, were more adaptable to a flat strip type of heater that could be formed to the tool as required. (Figure 20).

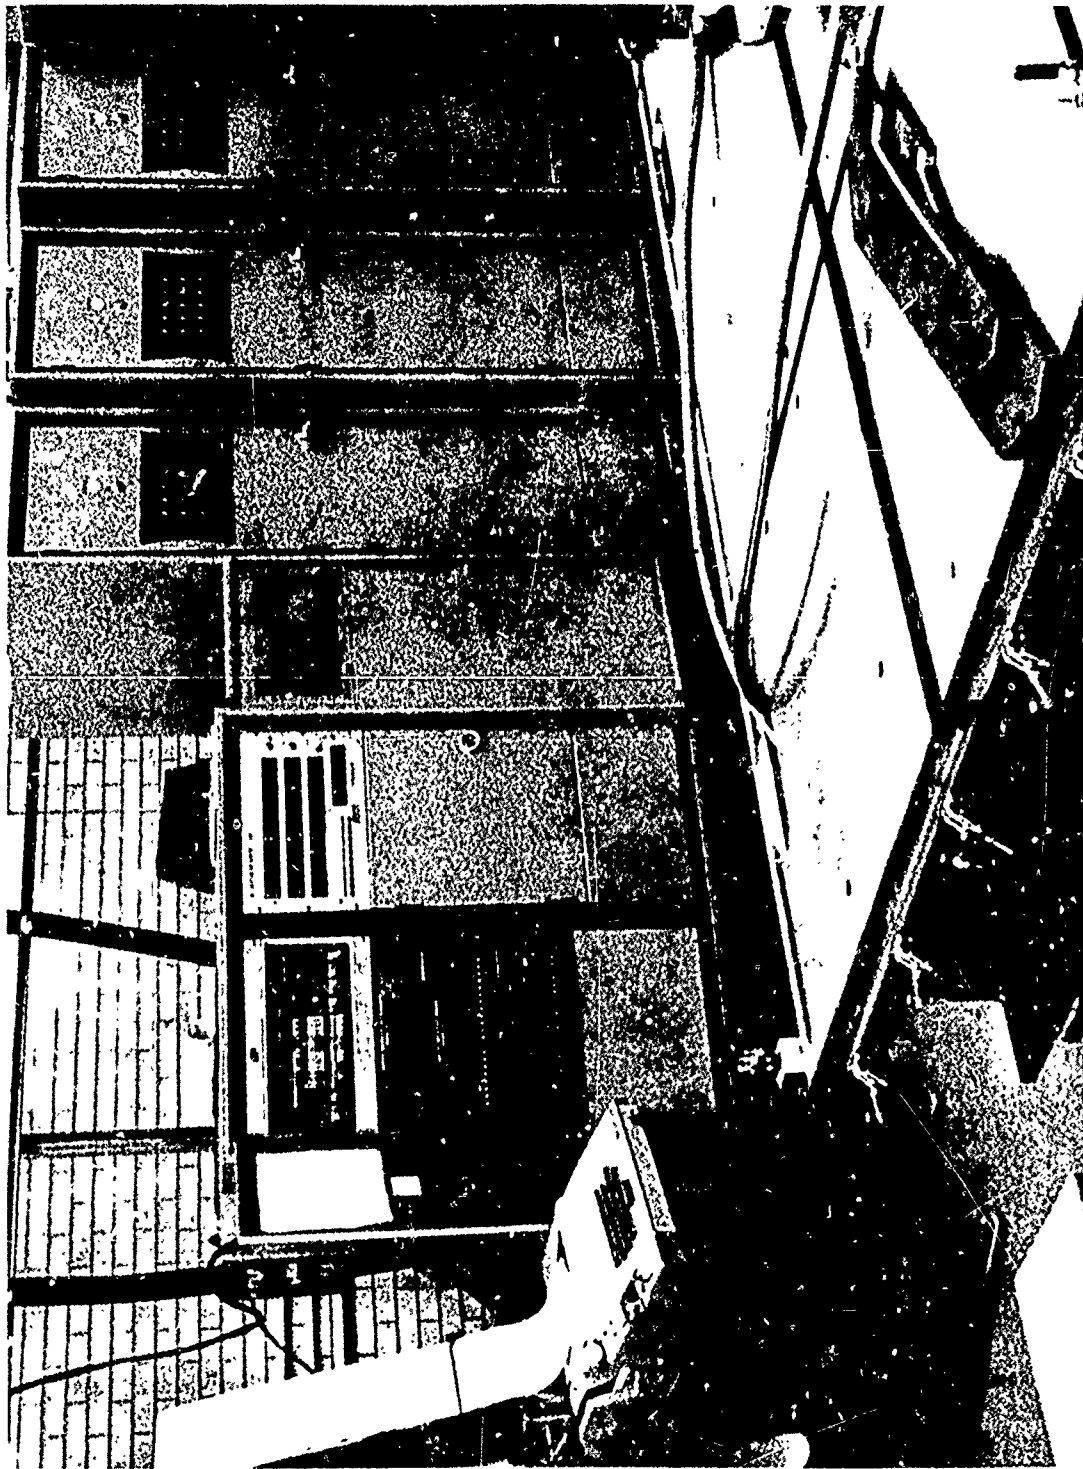
*Figure 22. Computer Based Heat Cycle Controller*

It was then decided to purchase a 60-zone computer-controlled ON/OFF switching control system as a facility item; the control system could be used for any program of this type, such as the UTTAS, ATB, etc. See Figure 22, computer controlled switching control system.

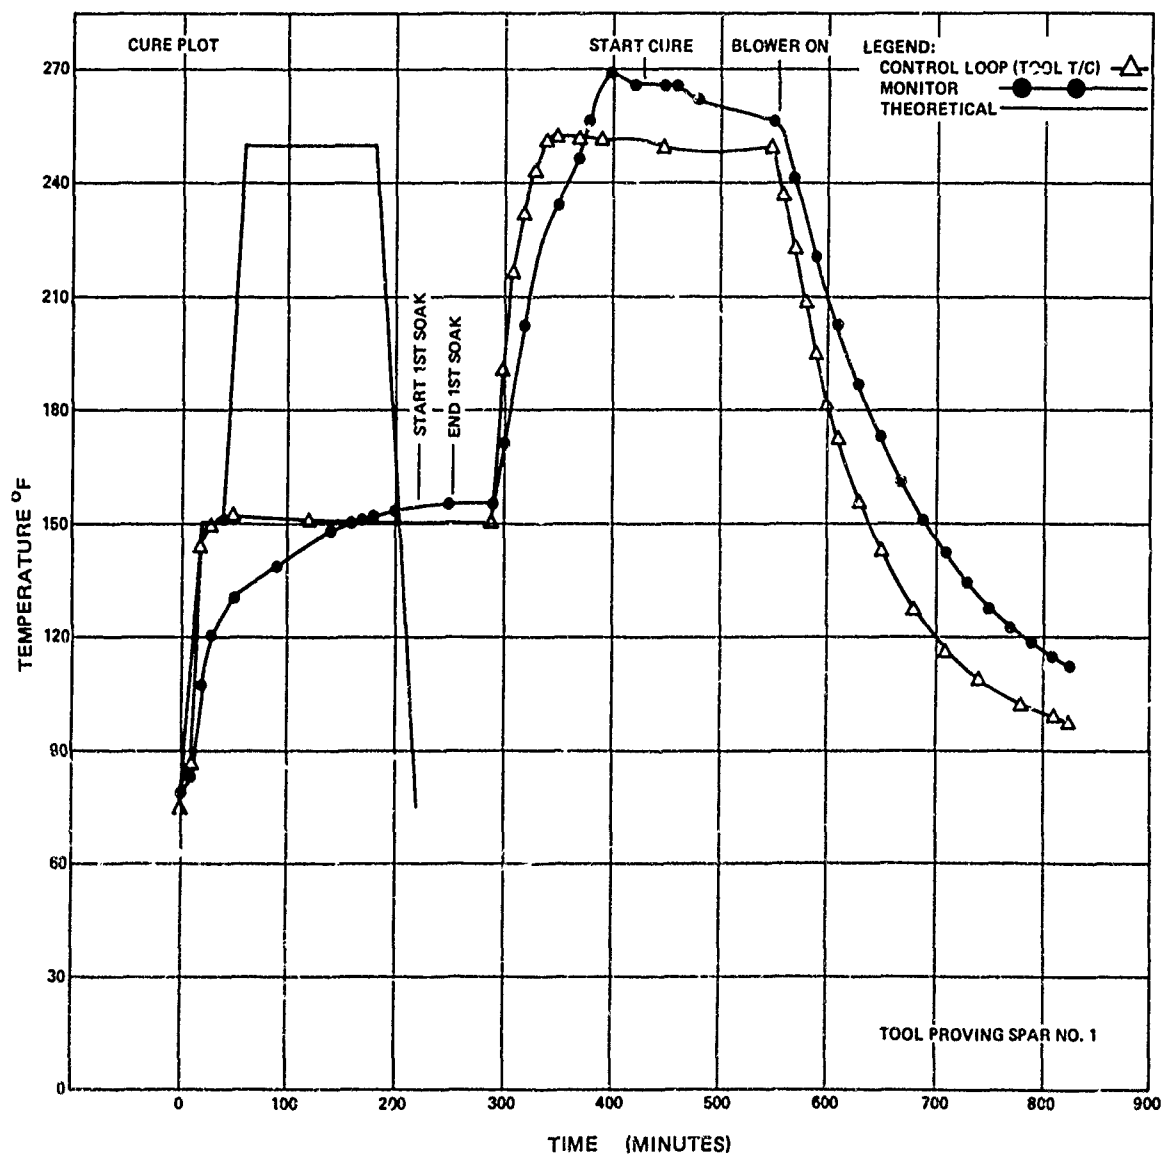
Figure 23. Spar Curing Operation Heating Cycle

The restraining base also has an integral air system used for cooling the fixtures at the end of a cure cycle. The base and the control unit performed as they were designed to do; the only problems encountered were some malfunctions of the computer unit. Replacement of some units was made, and the system performed well for the remainder of the program.

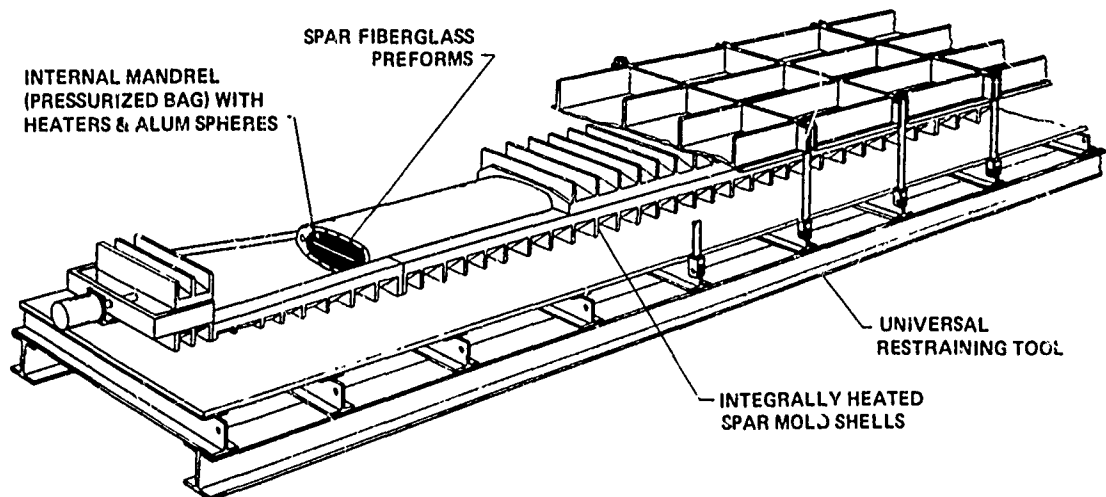
*Figure 24. HLH Blade Spar Curing*

The common base, or as it is better known, the universal restraining fixture FMIT SK301-10167 (Figures 24 and 25), was designed with power plugs and thermocouple jacks wired into the control unit so that any fixture could be heated. The base was built with a system of T slots for mounting various size fixtures and maintaining them in a plane through the cure cycle. A cover was provided over its full length to eliminate heat loss and also to give more uniform heat to the fixtures (Figure 23).

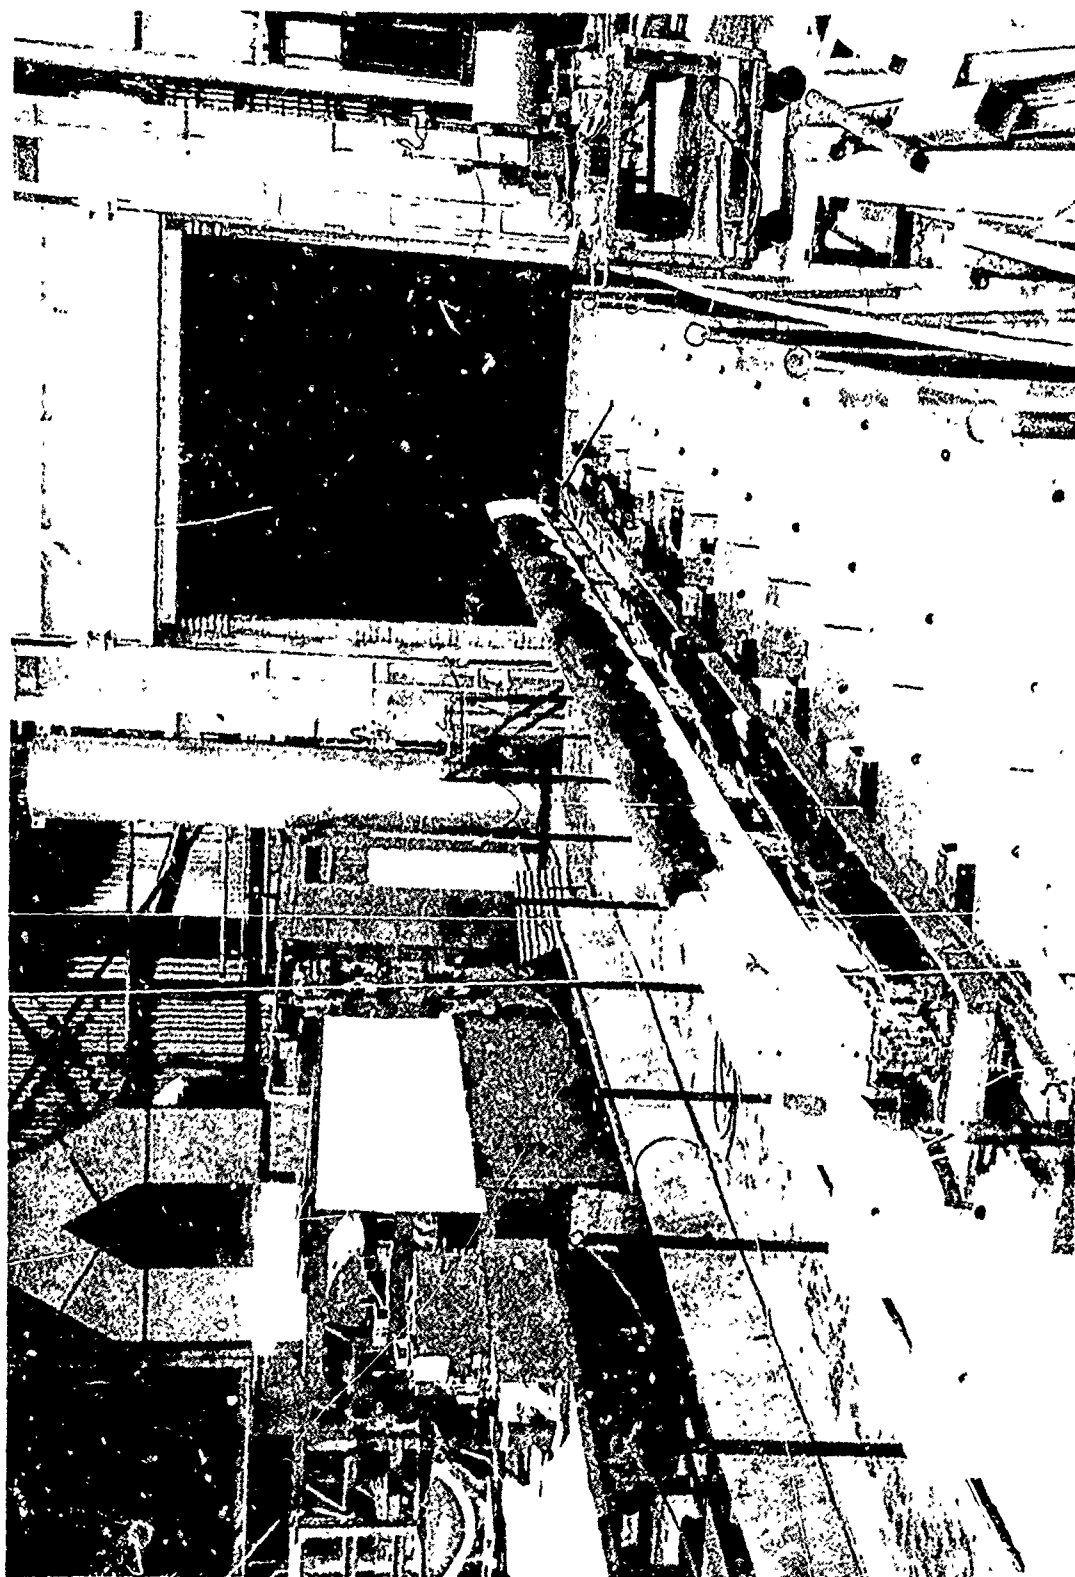
Figure 26. Titanium Cap Forming Tool with Base

For the short time allotted to the development of full length tooling, results were good. The major defects in the eight titanium caps produced for the ATC program were:

1. Form of radii at L.E. was oversize
2. Outboard section from Station 469.2 to the tip (Station 552) had a chordwise bow.
3. Buckles and caves in the outboard area

The leading edge radius of the Inconel mandrel will be reduced to correct the oversize condition on the cap. The out-board section of the mandrel is to be moved chordwise approximately 0.150 inches to correct the bow; better control of expansion (part vs. tool) should help remove the buckles and caves.
